Field Validation and Demonstration Reports and Recommendations

Deliverable number: Merge D5.4 and D5.5

Deliverable Reports D5.4 and D5.5, Issue date on 09 November 2018

INSITER - Intuitive Self-Inspection Techniques using Augmented Reality for construction, refurbishment and maintenance of energy-efficient buildings made of prefabricated components.

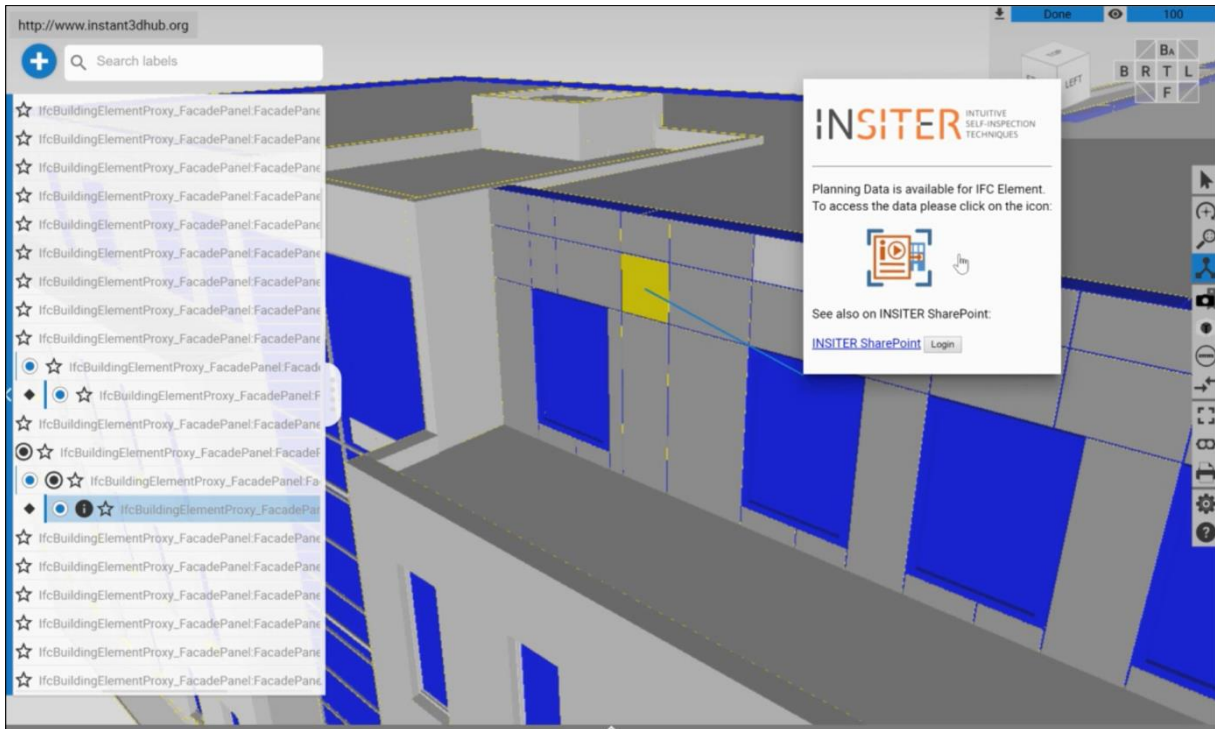
Figure 10: Exemplary BIM element selection of facade element cornering the INSITER Use Case Demo in Cologne with access to referenced planning data

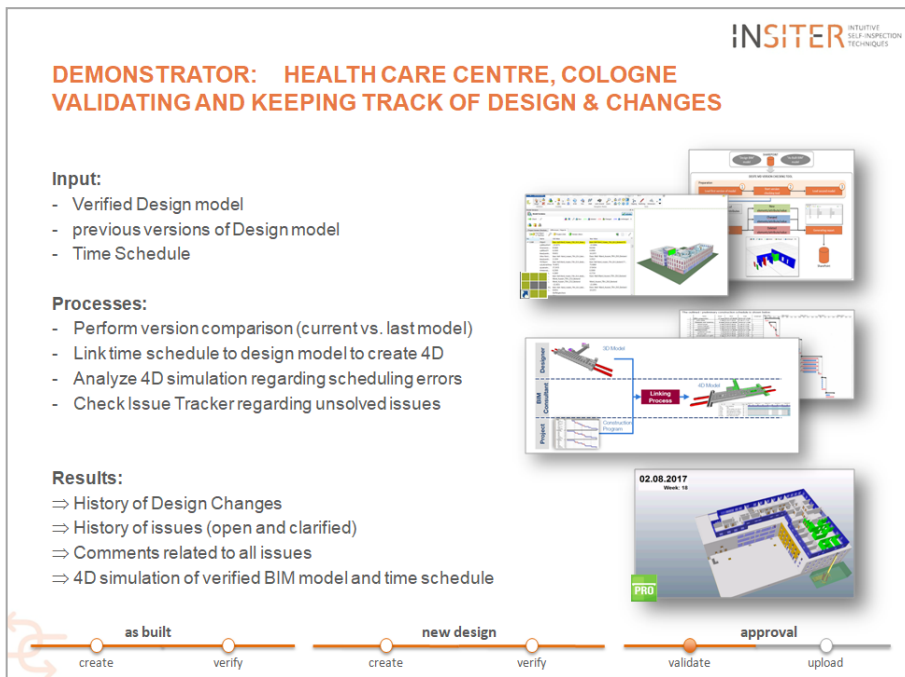
Figure 20: Track of design and changes

The existing building environment is providing the most critical influence on geometrical inconsistencies that cause adding up tolerance problems. To identify the critical errors and qualify the identified deviations a cross check is easy to perform and delivers the data needed to prepare a qualified decision on site following easy decision making criteria. For an example good enough, possibly to be changed –taking into account influences on neighboured pre-fab panels or joints of panels or joints of panels with the existing building structure- or definitely to be changed criteria have to be precisely defined. This process of identification has been exemplary performed and analysed at the Cologne site.

The input needed is the verified design model and the previous versions. Based on a time machine approach –like done in intelligent back-up systems for data storage- the difference between the models can be identified based on the time level assigned to the different versions related to their adjustment. The output is an inventory recording the history of design changes caused by the influence of positioning the components on site. As the time related data are integrated in the as designed survey this data material can be named as 4D BIM model data.

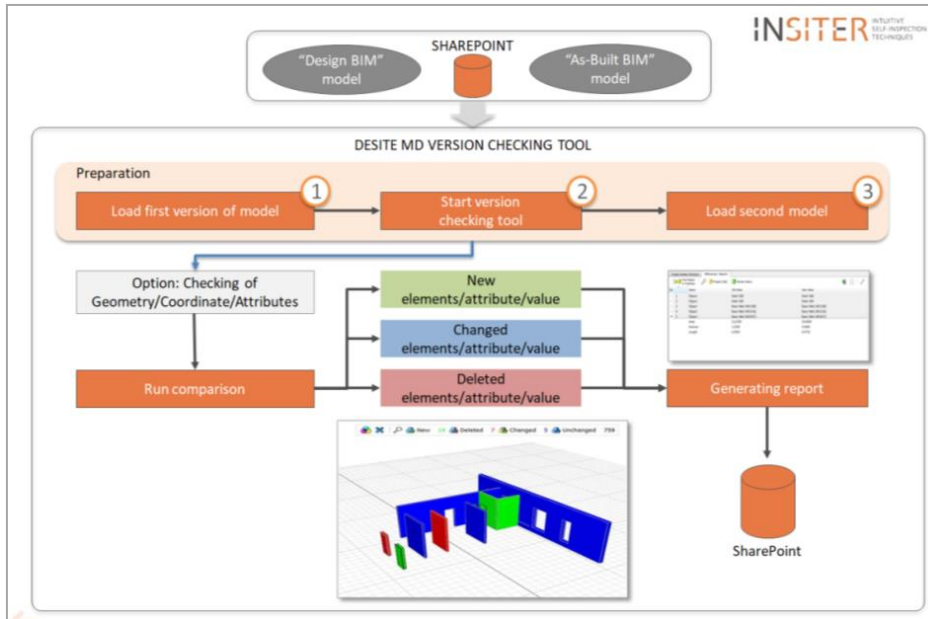
Figure 21: Scheme version comparisons

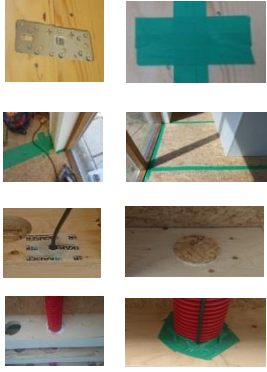
<ul style="list-style-type: none"> • Tape fixing plates; • Tape the joints between elements (one line from ceiling, walls and floor); • Repair holes above column with wooden block and tape it airtight; • Place wooden inlay in the floor and tape it airtight; • Make lead-through for cables airtight; • Place wooden rounds and make it airtight for under / over pressure; • Make an airtight lead-through for ducts and cables.

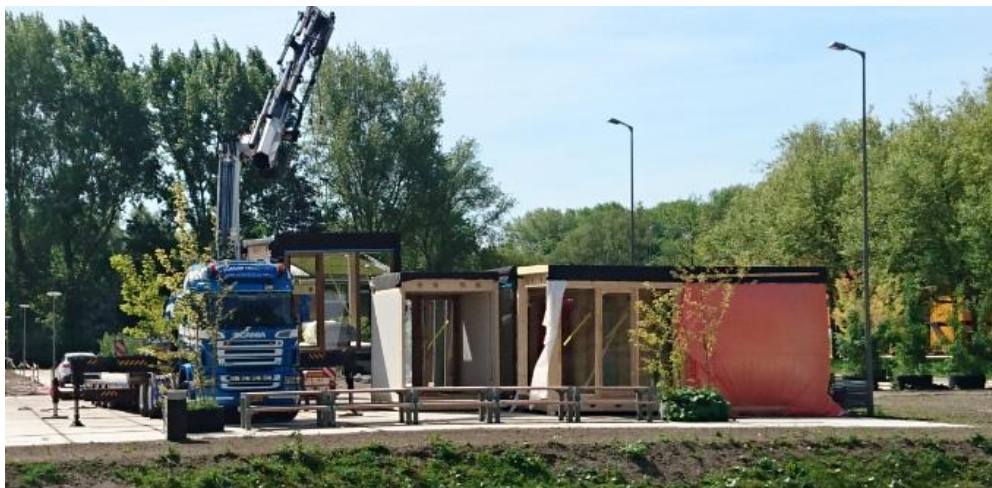
Figure 38: Delivery and storage of the modules

- The storage place was fit for the temporary storage of the modules.
- A good entrance control of the received additional materials for mounting the modules was missing.

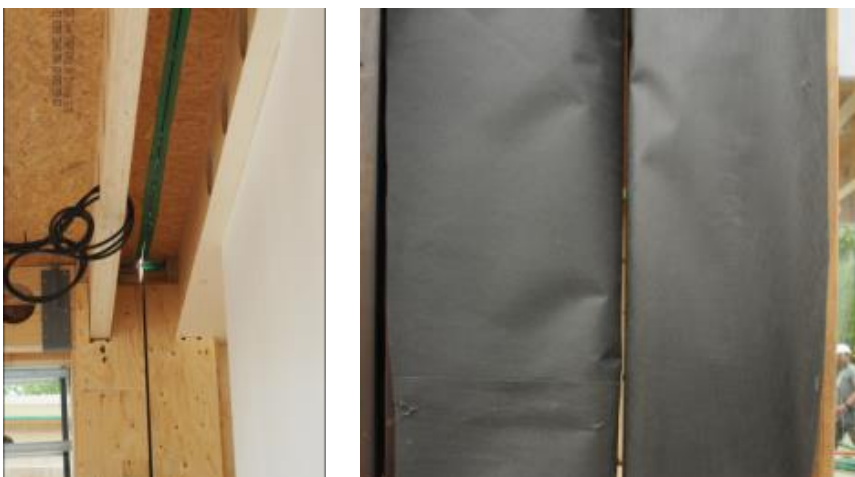
Figure 40: Examples of situations where the elements are not 100% connected yet.

This was repaired during the mounting and fixation of the elements.

- Threshold – no visual gaps are allowed between the elements and between the entry of pipes, ducts and cables through floor, ceiling and walls. Although we can calculate the allowed openings of the whole building depending on the size of the building and the airtightness demands, we don't accept any visual openings.

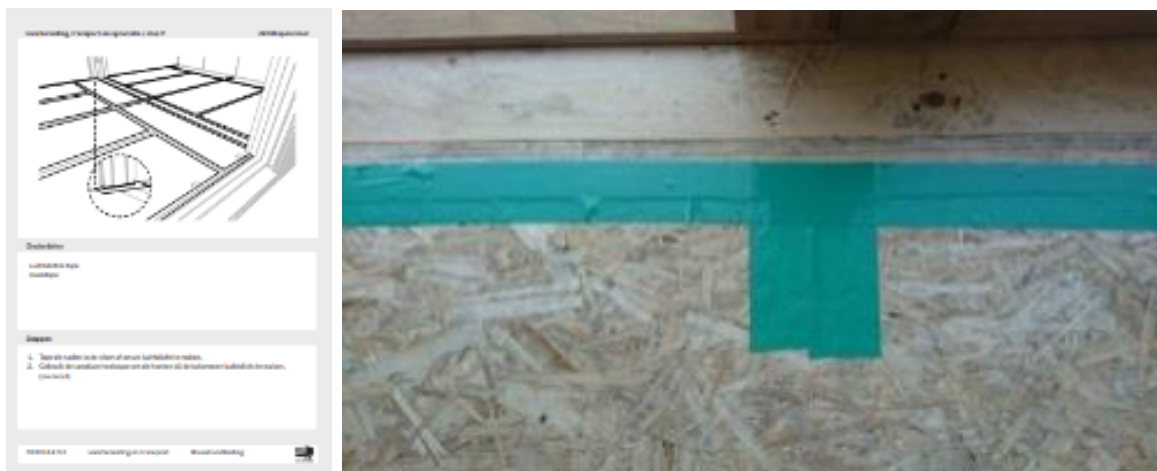
Figure 41: Adhesive tape instruction and application

- Threshold – adhesive tape applied according to the Ikea-like manual in the right way without interruption.
- Evidence: photos

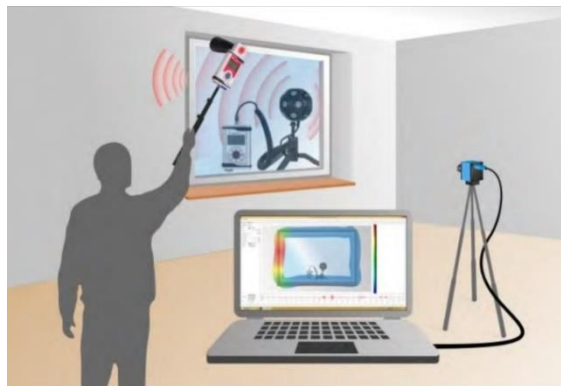
Figure 50: Animation of the test setup (source Sonotec)

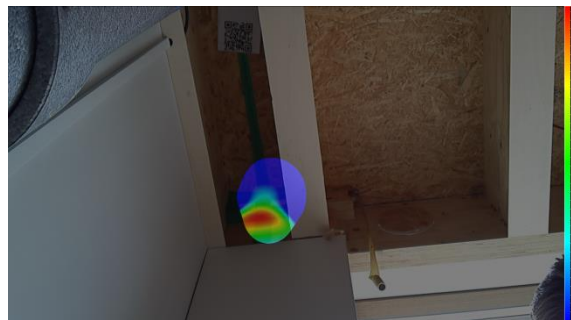
The receiver is sensitive for knocking against hard surfaces. A distance spacer is not used because the scratching of the spacer influences the results. We rejected the result of this measurement because of measurement error.

Figure 54: Misinformation of air leak caused by sensitivity of the receiver for knocking against hard surfaces

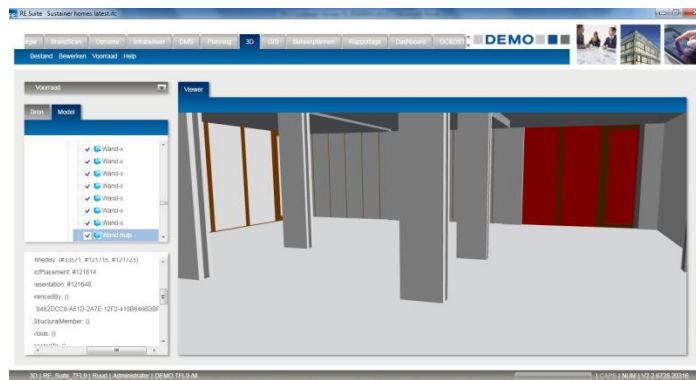
Figure 55: Position in the BIM-model and visual inspection

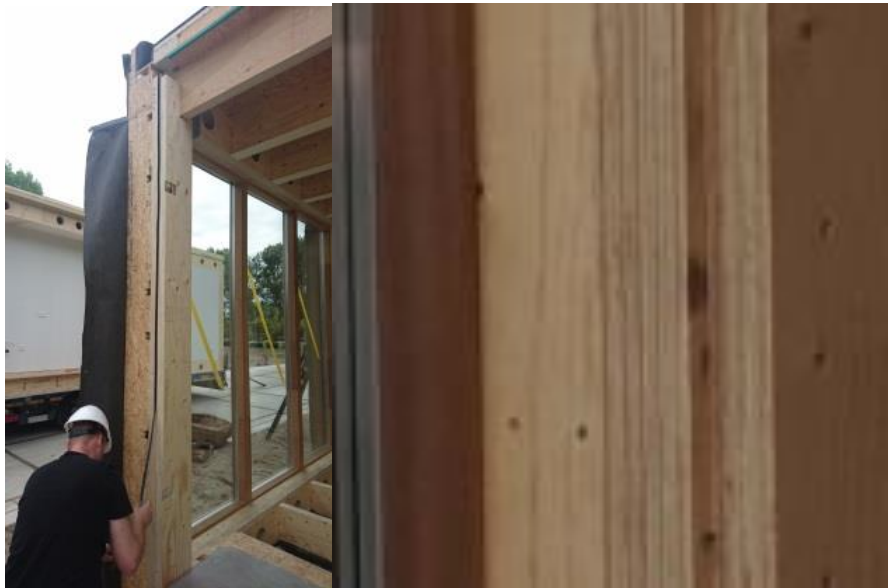
Figure 57b: Proof of the use of airtight sealant and the situation before finishing (not on the exact position of the air leak)

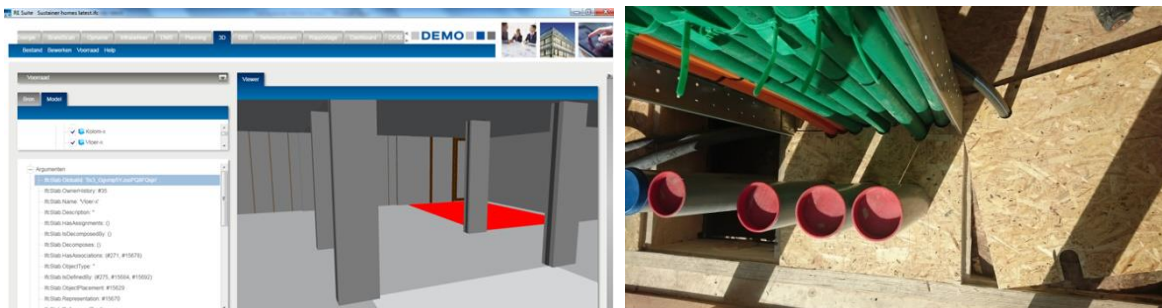
- **Threshold:** The difference in sound pressure level between the relative small hole near the orange cable entry (-86 dB illustrated as red in the image) and airtight places (-100dB illustrated as blue in the image) is below the threshold of 20dB (Figure 59).
- **Action:**
 - This air leak is relative small and does not demand extensive re-work. A little more attention to the connection of the adhesive tape to the orange cable will do.
 - Feedback to the design phase to come up with better solutions for cable and duct entries.

Figure 58: Cable and duct entry

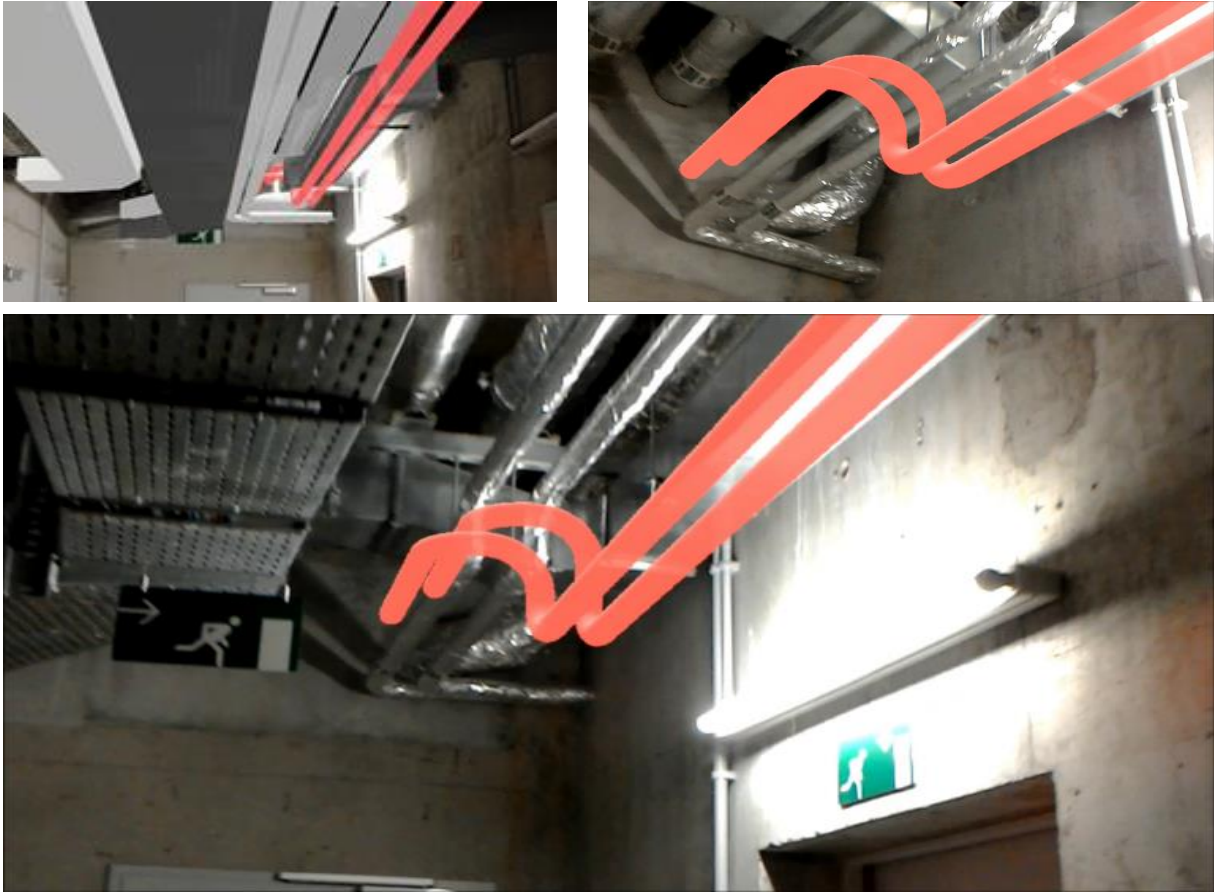
Figure 84: Visual comparison example between BIM-based MEP model and the planned-to-be target state and installation of the MEP system to be conducted at Fraunhofer example building with MS HoloLens.

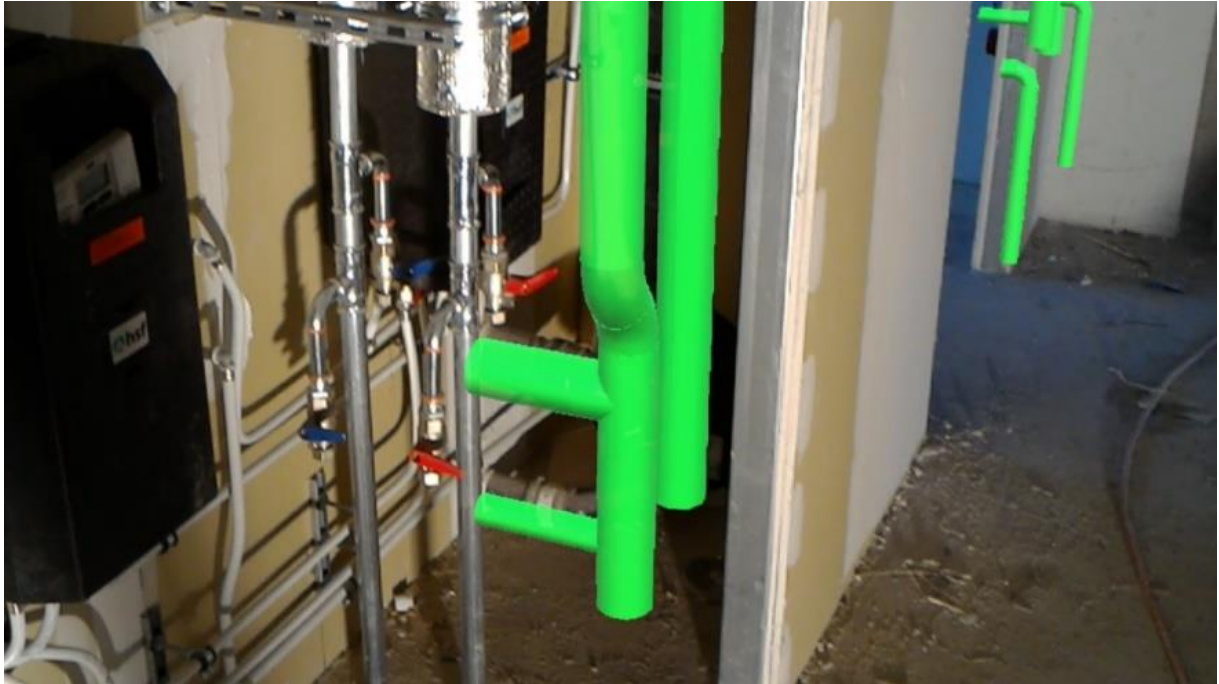
Figure 106: INSITER HoloLens BIM-based Mixed Reality App – On-Site Demonstration focus on MEP with particular visualization of one component (here: waste water system, for example)

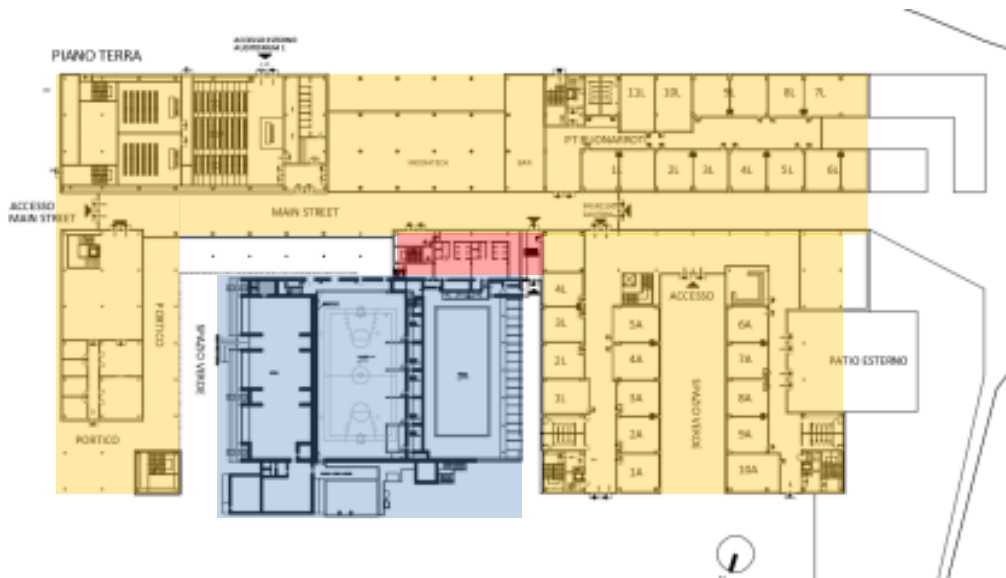
The new School Complex (highlighted in yellow) will have a four storey building that will “surround” the gym/pool building (in light blue). The interface (in red) is represented by the lockers room and the staircase that will connect the school with the fitness centre. The relation between new and existing buildings is crucial in the proper realization of the building, especially in terms of safety works for local demolition and subsequent installation of new building components, in order to avoid thermal bridges and differences in energy performance between the existing elements and the new components to be installed.

Figure 123: Design condition - General plan of the new educational facility and the remaining gym building

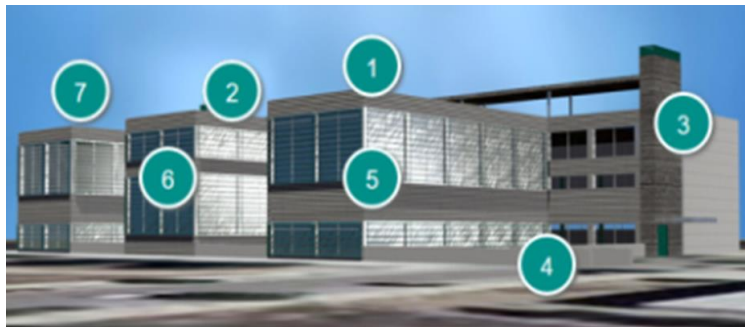
Figure 141: Deviation check-points

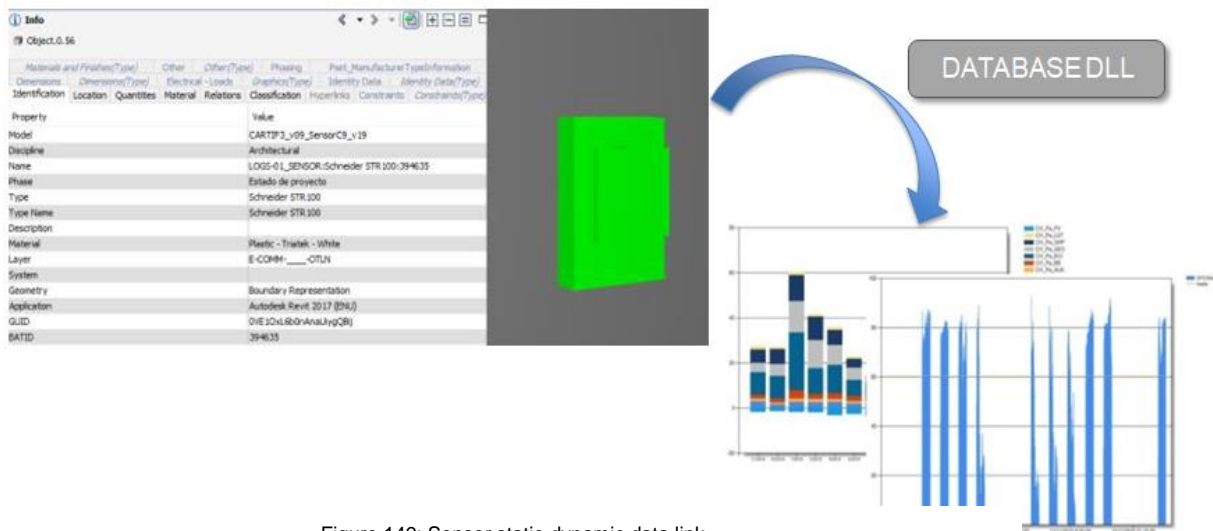
Figure 149: Sensor static-dynamic data link

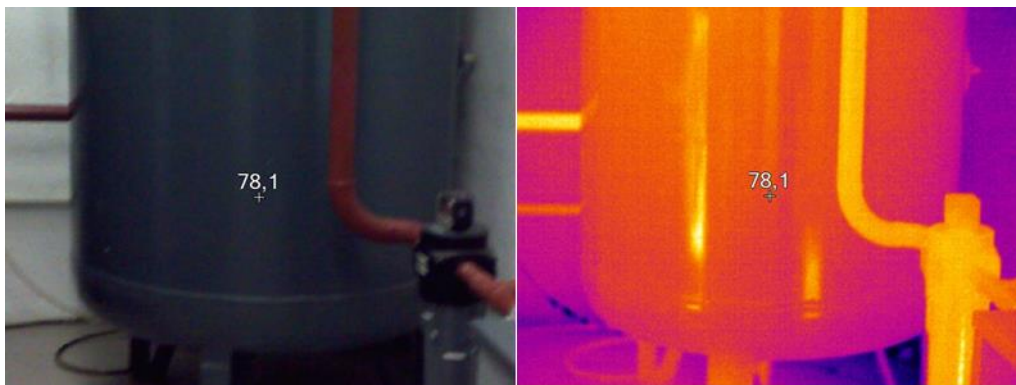
Figure 154: Thermography of the solar storage tanks

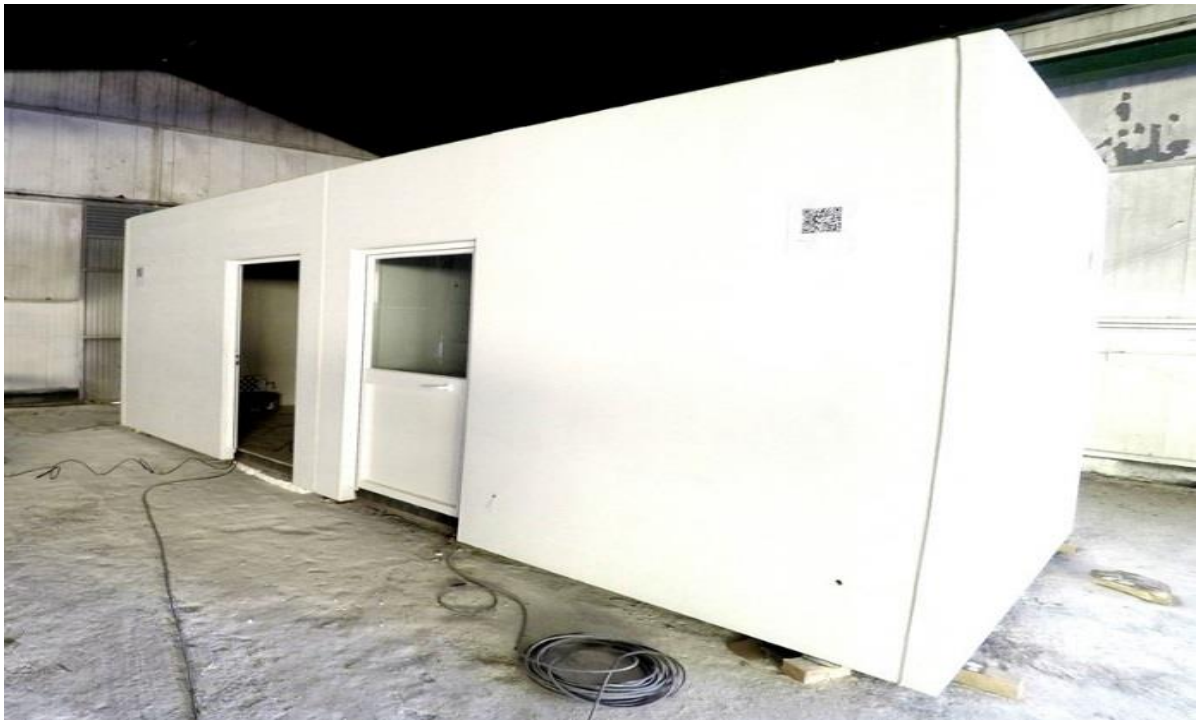
Figure 159: Factory testing

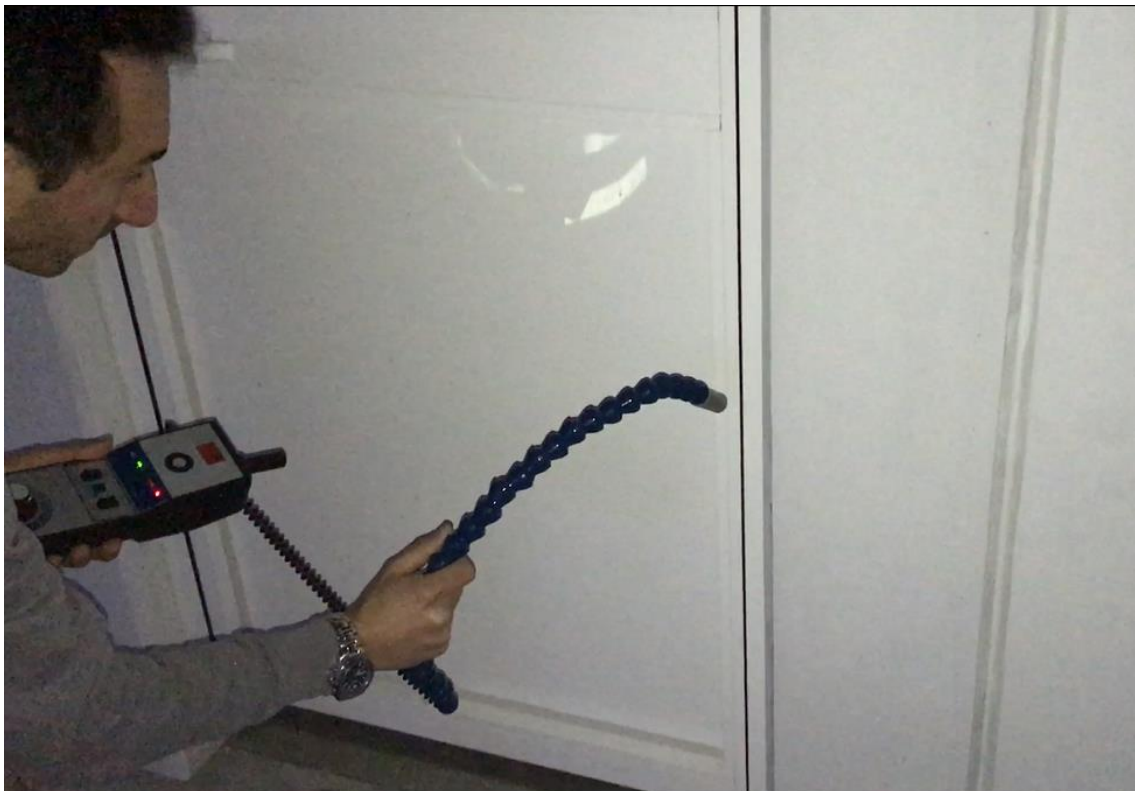
Figure 184: Ultrasound test

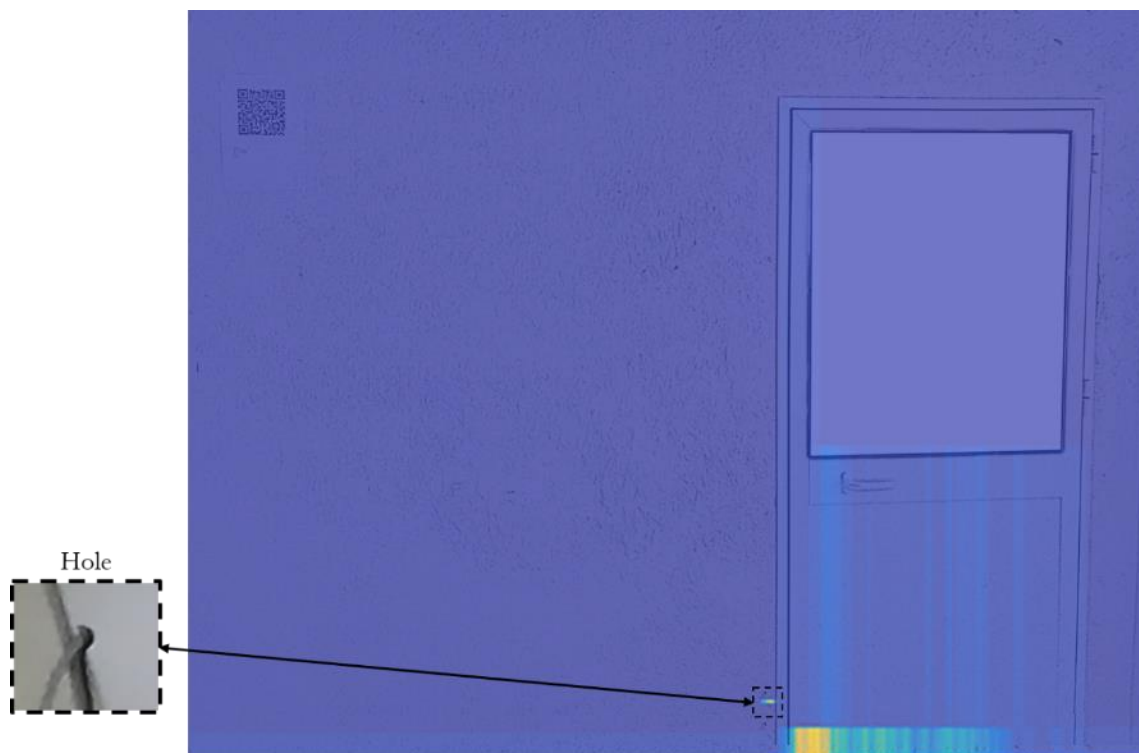
Figure 185: Ultrasonic signal superimposed to Wall 2 picture

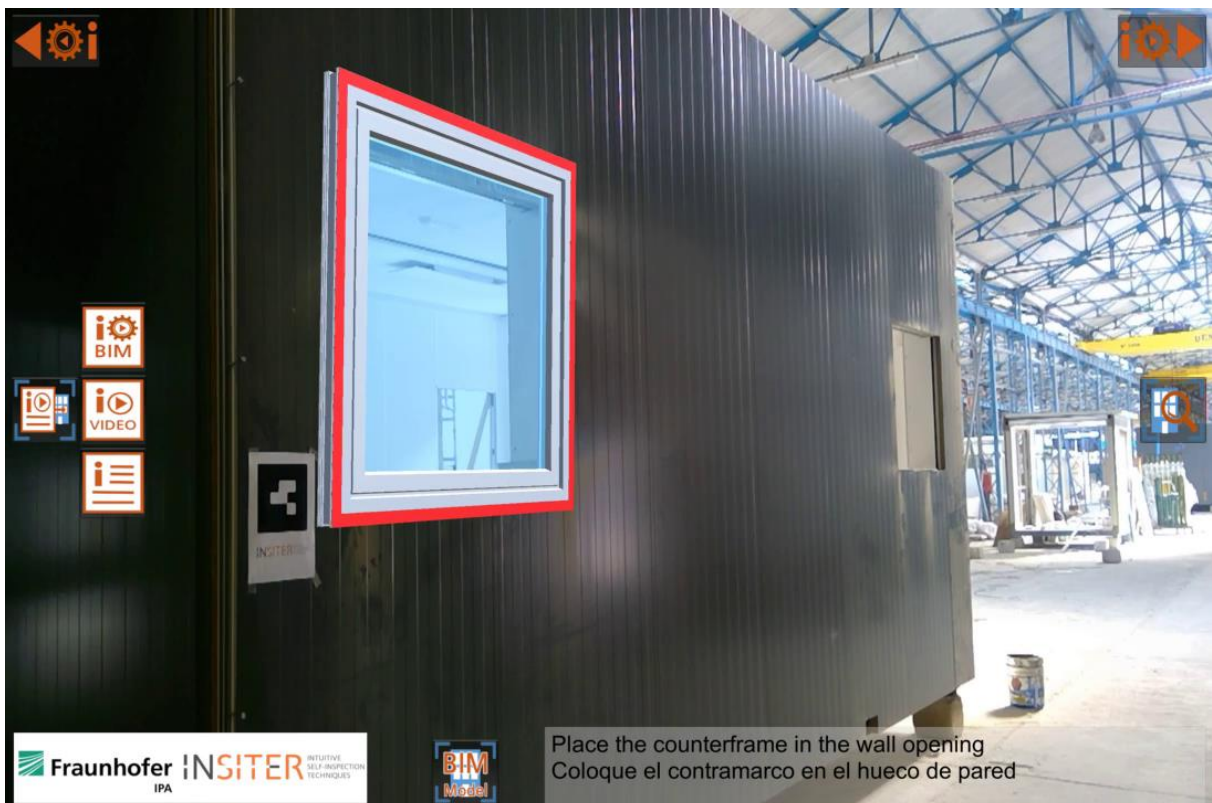
Figure 194: INSITER BIM-based Self-Instruction AR App screenshot - Visualizing self-instruction information for BIM elements and to be installed window components for the DRAGADOS Use Case Demo in Seville on tablet computers

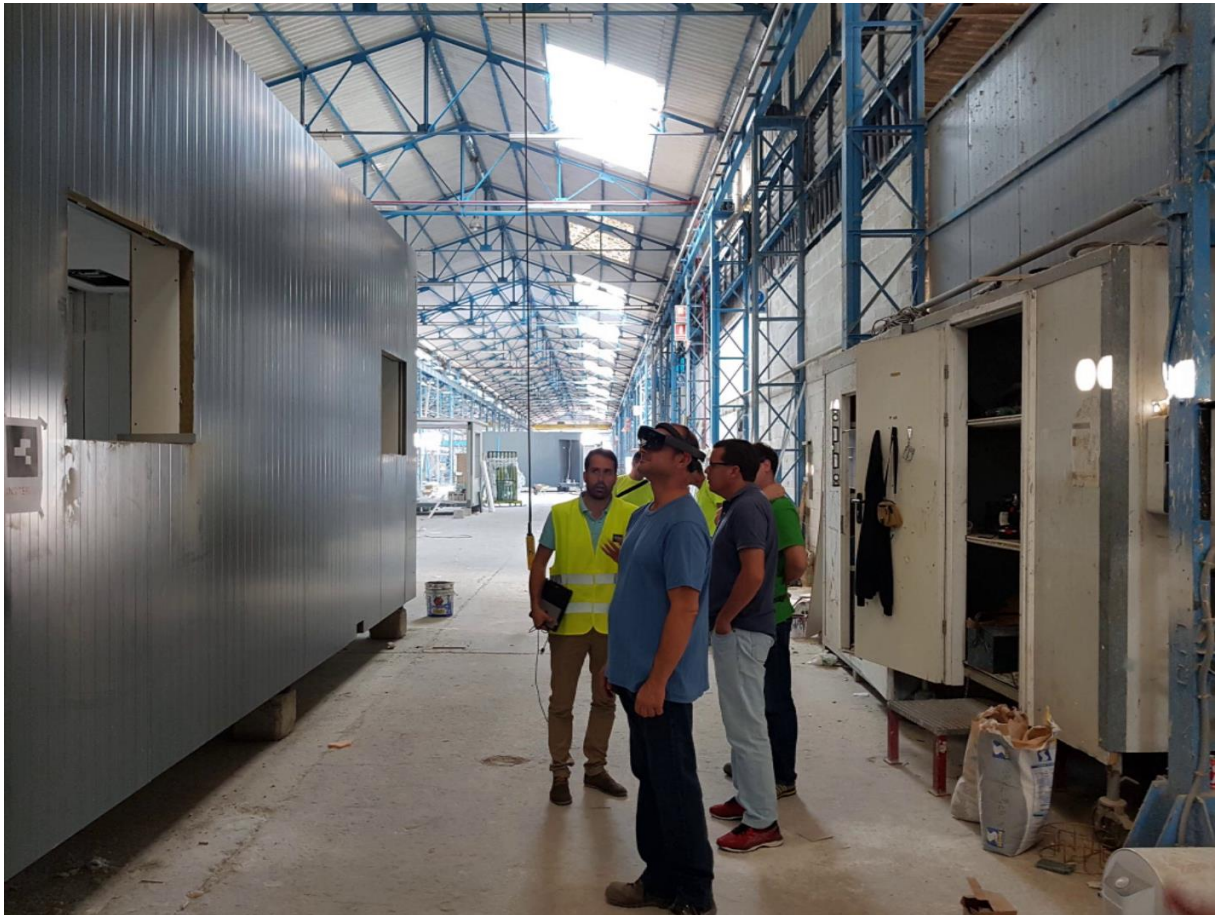
Figure 196: INSITER BIM based Augmented Reality Apps – On-Site Demonstration with construction workers at DRAGADOS
